**Flood Control Project Maintenance
Levee Inspections**

Fall 2018 Levee Maintenance Deficiency Summary Report

Sacramento River Basin

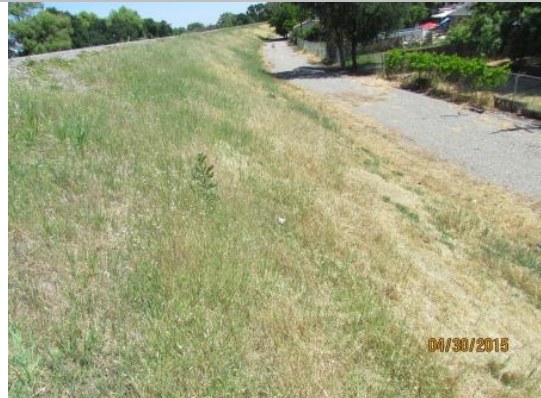
Photo 1 of 2 : FA_2018_NA0001_51_164_20180911_00050.jpg

LM Start	0.48	Rating **	A/W	Issue No.	164 (cont)
LM End	0.48	Issue Type +	Ma	Location *	LS

Another view of the depression on the landside levee slope.

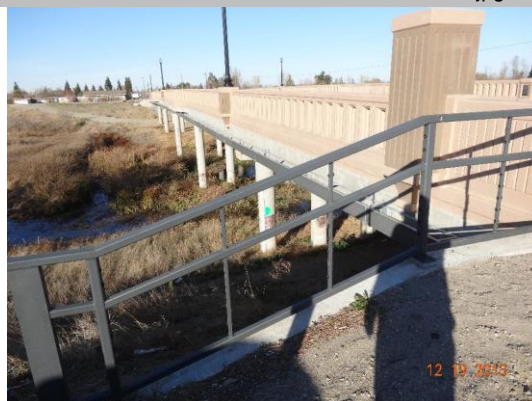
Photo 1 of 3 : UCIP_FA_2018_53488_57042.jpg

UCIP Comments: 07/18/2018 Crossing appears to be the same as last time. Markers have not been placed. PG&E provided supporting documentation that this crossing is in good shape. Plus it is getting raised to the 200-year water surface elevation. PG&E records for this distribution main indicate that there were no leaks found on the 06/2017 leak survey and the pipeline is operating correctly according to the 12/2016 CP inspection. Crossing is downgraded to "Non-Urgent" until the gas line is raised to the 200-year level. (A. McDonald - DWR UCIP)8/11/2016 Markers still missing. LMA representatives, Tim Kerr and Richard Marck, provided permit for 4-inch PG&E gasline to be raised to 200-year water surface elevation. Pipe will be modified on both the right and left bank. Elevation through the levee will need to be modified once pipe is raised through levee. (DWR UCIP - omagana)12/19/2013 no markers visible on waterward or landward side indicating this is a gas line--need to contact owner to determine if this crossing is gas line. (DWR UCIP - omagana)

View of WS--pipe suspended along downstream face of bridge.

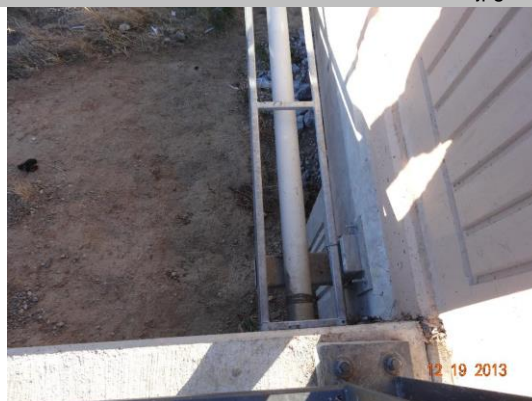
Photo 3 of 3 : UCIP_FA_2018_53488_57040.jpg

UCIP Comments: 07/18/2018 Crossing appears to be the same as last time. Markers have not been placed. PG&E provided supporting documentation that this crossing is in good shape. Plus it is getting raised to the 200-year water surface elevation. PG&E records for this distribution main indicate that there were no leaks found on the 06/2017 leak survey and the pipeline is operating correctly according to the 12/2016 CP inspection. Crossing is downgraded to "Non-Urgent" until the gas line is raised to the 200-year level. (A. McDonald - DWR UCIP)8/11/2016 Markers still missing. LMA representatives, Tim Kerr and Richard Marck, provided permit for 4-inch PG&E gasline to be raised to 200-year water surface elevation. Pipe will be modified on both the right and left bank. Elevation through the levee will need to be modified once pipe is raised through levee. (DWR UCIP - omagana)12/19/2013 no markers visible on waterward or landward side indicating this is a gas line--need to contact owner to determine if this crossing is gas line. (DWR UCIP - omagana)

View of pipe suspended over waterway.

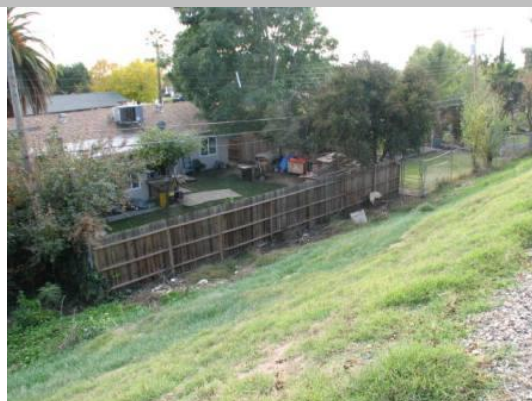
Photo 1 of 1 : FA_2018_NA0001_51_183_20180911_00060.jpg

LM Start	0.77	Rating **	U	Issue No.	183
LM End	0.77	Issue Type +	En	Location *	LS
Category	Earthen Levee			GPS Latitude/Longitude	
				Start	End
Item	Encroachments			38.624016 °	38.624016 °
				-121.455193 °	-121.455193 °
DWR ID	DWR_NA0001_01_s_2012_183				
Comment Code					
FE : Fence					
Inspector Comment					
Dog-eared fence built within 10' of the toe

11/17/2011 Wooden privacy fence.

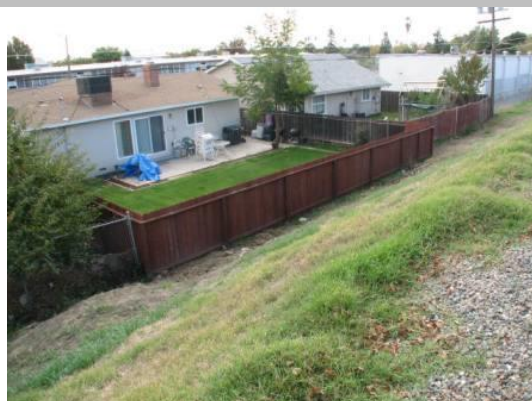
Photo 1 of 1 : FA_2018_NA0001_51_182_20180911_00059.jpg

LM Start	0.95	Rating **	U	Issue No.	182
LM End	0.95	Issue Type +	En	Location *	LS
Category	Earthen Levee			GPS Latitude/Longitude	
				Start	End
Item	Encroachments			38.625072 °	38.625072 °
				-121.452225 °	-121.452225 °
DWR ID	DWR_NA0001_01_s_2012_182				
Comment Code					
FE : Fence					
Inspector Comment					
Dog-eared wooden fence built within 10' of the toe.

11/17/2011 Wooden privacy fence built at the levee toe.

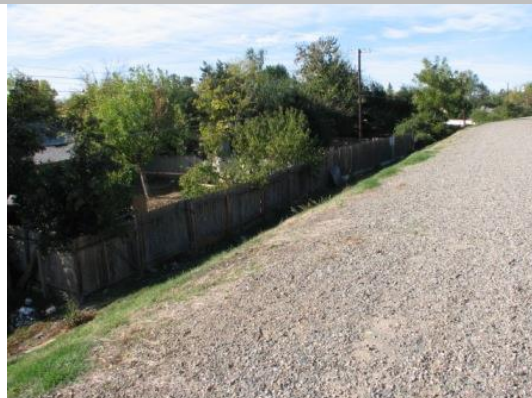
Photo 1 of 1 : FA_2018_NA0001_51_20_20180911_00017.jpg

LM Start	1.18	Rating **	U	Issue No.	20
LM End	1.18	Issue Type +	En	Location *	LS
Category	Earthen Levee			GPS Latitude/Longitude	
				Start	End
Item	Encroachments			38.624900 °	38.624900 °
				-121.448037 °	-121.448037 °
DWR ID	DWR_NA0001_01_s_2012_20				
Comment Code					
FE : Fence					
Inspector Comment					
Dog-eared wooden fence is built against the levee slope.

Photo of solid fences built against the levee slope.

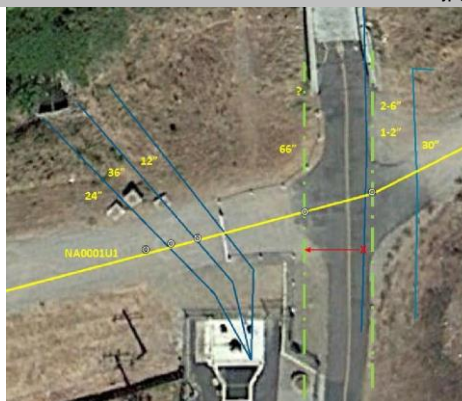
Photo 1 of 1 : UCIP_FA_2018_31178_57059.jpg

Comment Code					
Inspector Comment					
FS_ID:31178 DS_ID:24248 EP_NO: 14575 Repair Type: Non-Urgent Crossing Status: Not Found UCIP Comments: 12/19/2013 Crossing is present in the layer provided by the City of Sacramento, however this crossing was not found in the field. Need to determine status of crossing. If crossing is no longer used, owner will need to coordinate with Central Valley Flood Protection Board to comply with Title 23. FIELD_STRUCT_DESC: 30-inch concrete encased steel water main through the levee, 4.5 feet below the crown. Steel cutoff wall around pipe at center of levee. (30-inch pipe authorized under Permit No. 14575, 1988 - City of Sacramento; 30-inch is scheduled to be cut and replaced under Permit No. 14575-1, 2016 - City of Sacramento) [Additional Reference(s): DWR Levee Log, 2002] FS Date: 12/19/2013

Alignment indicated in blue is approximate locations for pipes that cross levee. Alignment information was obtained from the City of Sacramento.

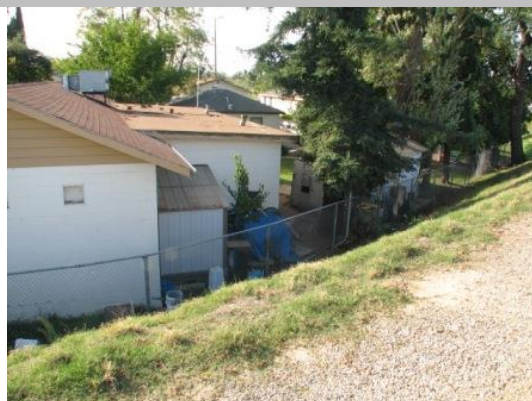
Photo 1 of 1 : FA_2018_NA0001_51_18_20180911_00016.jpg

LM Start	1.26	Rating **	U	Issue No.	18
LM End	1.26	Issue Type +	En	Location *	LS
Category	Earthen Levee			GPS Latitude/Longitude	
				Start	End
Item	Encroachments			38.625395 °	38.625395 °
				-121.446608 °	-121.446608 °
DWR ID	DWR_NA0001_01_s_2012_18				
Comment Code					
BU : Building					
Inspector Comment					
Cement block building within 10-ft of toe. Storage of equipment and supplies blocking visibility.

Fall 2009 photo: Buildings and fence near levee toe.

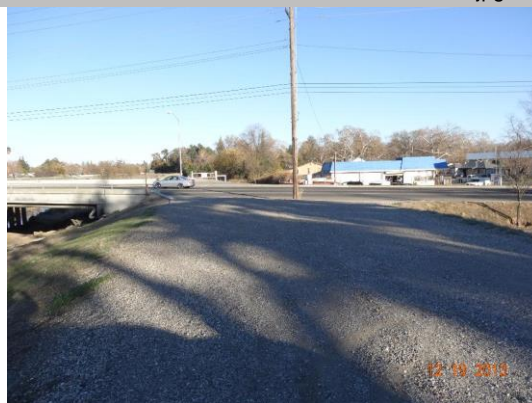
Photo 1 of 3 : UCIP_FA_2018_30085_55489.jpg

LM Start	1.28	Rating **	M	Issue No.	187
LM End	1.28	Issue Type +	En	Location *	
Category	Supplemental			GPS Latitude/Longitude	
				Start	End
Item	DWR UCIP Field Study			38.625500 °	38.625500 °
				-121.446390 °	-121.446390 °
DWR ID	24576				
Comment Code					
Inspector Comment					
FS_ID:30085					
DS_ID:24576					
EP_NO: N/A					
Repair Type: Non-Urgent					
Crossing Status: Indicator Found					
UCIP Comments: Unable to confirm location--will need to coordinate with owner to determine if crossing is still active and determine location.					
FIELD_STRUCT_DESC: 1 of 3: 16-inch pipe through the levee, 8 feet below the crown. Floodgates within the levee across the channel, installed under Permit No. 14480 (1986). [Additional Reference(s): DWR Levee Log, 2002]					
FS Date: 12/19/2013

Overview of levee crown at crossing.

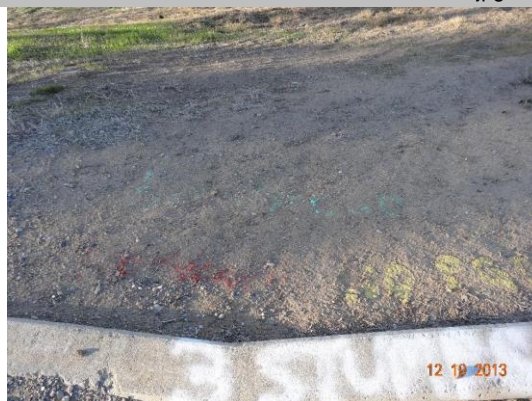
Photo 2 of 3 : UCIP_FA_2018_30085_55488.jpg

Underground service alert (USA) paint markings visible on waterward slope.

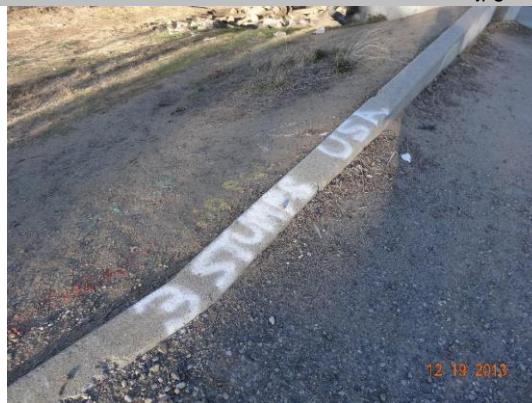
Photo 3 of 3 : UCIP_FA_2018_30085_55490.jpg

Concrete floodwall along waterward shoulder.

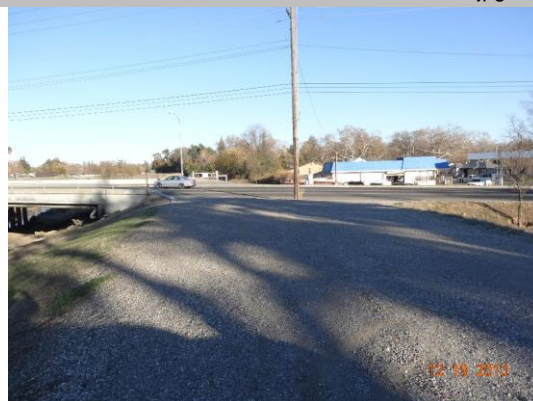
Photo 1 of 3 : UCIP_FA_2018_29732_54976.jpg

LM Start	1.28	Rating **	M	Issue No.	188
LM End	1.28	Issue Type +	En	Location *	
Category	Supplemental			GPS Latitude/Longitude	
				Start	End
Item	DWR UCIP Field Study			38.625500 °	38.625500 °
				-121.446390 °	-121.446390 °
DWR ID	24577				
Comment Code					
Inspector Comment					
FS_ID:29732					
DS_ID:24577					
EP_NO: N/A					
Repair Type: Non-Urgent					
Crossing Status: Indicator Found					
UCIP Comments: Unable to confirm location--will need to coordinate with owner to determine if crossing is still active and determine location.					
FIELD_STRUCT_DESC: 2 of 3: 6-inch pipe through the levee, 8 feet below the crown. Flap gate on the waterside (WS) end. Floodgates within the levee across the channel, installed under Permit No. 14480 (1986). [Additional Reference(s): DWR Levee Log, 2002]					
FS Date: 12/19/2013

Overview of levee crown.

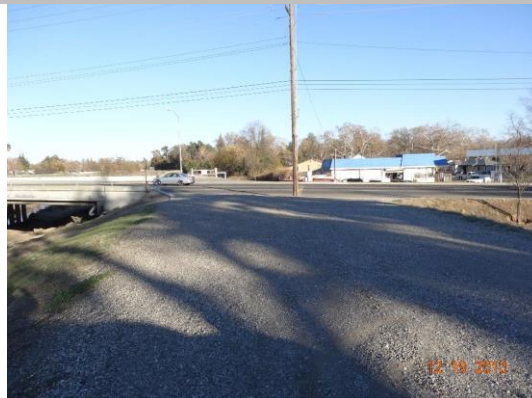
Photo 1 of 3 : UCIP_FA_2018_53490_75855.jpg

Comment Code					
Inspector Comment					
FS_ID:53490 DS_ID:24252 EP_NO: 15152-1 Repair Type: Non-Urgent Crossing Status: Found UCIP Comments: 07/18/2018 Markers missing. This pipeline is abandoned, cut, and capped at the north end of the Rio Linda Blvd bridge. The pipe going through the north levee is open on the WS end. This line is supposed to be raised to the 200-year water surface elevation. PG&E records for this distribution main indicate that there were no leaks found on the 07/2017 leak survey and the pipeline is operating correctly according to the 12/2016 CP inspection. Crossing downgraded to "Non-Urgent" pending documentation that this gas line has been abandoned properly. (A. McDonald - DWR UCIP)8/11/2016 Markers still missing. Unable to confirm if line will be raised to 200-year water surface elevation at this site. (DWR UCIP - omagana)12/19/2013 Need to confirm if this crossing is gas line. Need to contact owner to determine status of crossing (active or inactive) and to determine last inspection date. Will need copy of letter showing crossings passed inspection. Missing utility markers. (DWR UCIP - omagana) FIELD_STRUCT_DESC: *ABANDONED* 4-inch steel gas main through the levee, 2.5 feet below the crown. Vent on the waterside (WS) shoulder. Unable to confirm if crossing will be raised to 200-year water surface elevation within Unit 1. Pipeline was abandoned, cut, and capped at the north end of the Rio Linda Blvd bridge. In case of an emergency related to this pipeline, PG&E has identified the following contacts: PG&E's local pipeline engineer, Mike Aronoff at 916-307-9472 (cell), and Gas Control (north) at 800-442-4743. For non-emergency issues, please contact the local PG&E Gas Pipeline Operations and Maintenance (GPOM) supervisors for the Sacramento region, David Wade at 209-639-1039 (cell), or Ron Hicks at 916-396-9038 (cell). (4-inch gas line installed under Permit No. 15152, 1989 - Pacific Gas & Electric Company [PG&E], 4-inch gas line raised above the 200-year water surface elevation under Permit No. 15152-1, 2016 - PG&E) [Additional Reference(s): DWR Levee Log, 2002] FS Date: 7/18/2018

View of levee crown where crossing should be--no markers found.

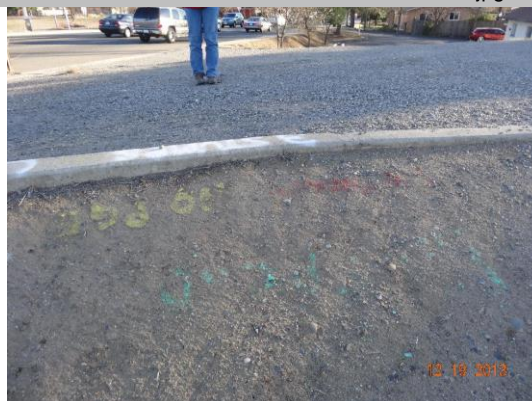
Photo 3 of 3 : UCIP_FA_2018_53490_75857.jpg

UCIP Comments: 07/18/2018 Markers missing. This pipeline is abandoned, cut, and capped at the north end of the Rio Linda Blvd bridge. The pipe going through the north levee is open on the WS end. This line is supposed to be raised to the 200-year water surface elevation. PG&E records for this distribution main indicate that there were no leaks found on the 07/2017 leak survey and the pipeline is operating correctly according to the 12/2016 CP inspection. Crossing downgraded to "Non-Urgent" pending documentation that this gas line has been abandoned properly. (A. McDonald - DWR UCIP)8/11/2016 Markers still missing. Unable to confirm if line will be raised to 200-year water surface elevation at this site. (DWR UCIP - omagana)12/19/2013 Need to confirm if this crossing is gas line. Need to contact owner to determine status of crossing (active or inactive) and to determine last inspection date. Will need copy of letter showing crossings passed inspection. Missing utility markers. (DWR UCIP - omagana)

Underground service alert (USA) markings found on WS shoulder, photo 2 of 2.

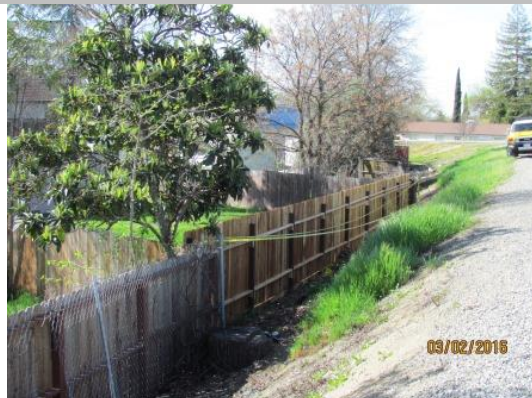
Photo 1 of 1 : FA_2018_NA0001_51_73_20180911_00047.jpg

LM Start	1.33	Rating **	U	Issue No.	73
LM End	1.33	Issue Type +	En	Location *	LS
Category	Earthen Levee			GPS Latitude/Longitude	
				Start	End
Item	Encroachments			38.625869 °	38.625869 °
				-121.445477 °	-121.445477 °
DWR ID	DWR_NA0001_01_f_2015_73				
Comment Code					
FE : Fence					
Inspector Comment					
Fence at LS toe.

View of the fence at the landside levee toe.

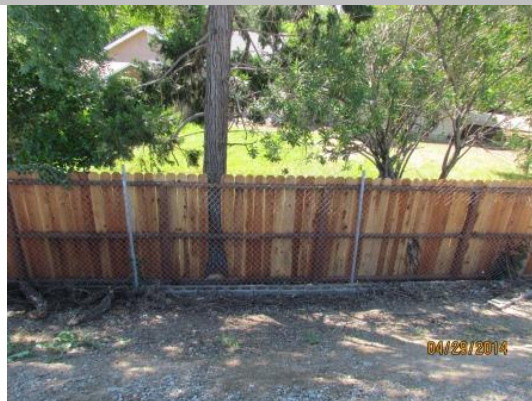
Photo 1 of 1 : FA_2018_NA0001_51_50_20180911_00032.jpg

LM Start	1.35	Rating **	U	Issue No.	50
LM End	1.35	Issue Type +	En	Location *	LS
Category	Earthen Levee			GPS Latitude/Longitude	
				Start	End
Item	Encroachments			38.625982 °	38.625982 °
				-121.445231 °	-121.445231 °
DWR ID	DWR_NA0001_01_s_2014_50				
Comment Code					
FE : Fence					
Inspector Comment

View of the fence at the landside levee toe obstructing visibility and access.

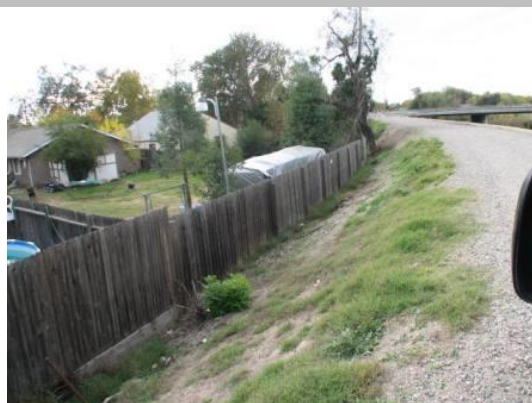
Photo 1 of 1 : FA_2018_NA0001_51_16_20180911_00015.jpg

LM Start	1.36	Rating **	U	Issue No.	16
LM End	1.36	Issue Type +	En	Location *	LS
Category	Earthen Levee			GPS Latitude/Longitude	
				Start	End
Item	Encroachments			38.626000 °	38.626000 °
				-121.444978 °	-121.444978 °
DWR ID	DWR_NA0001_01_s_2012_16				
Comment Code					
FE : Fence					
Inspector Comment					
Wooden privacy fence

11/17/2011 Wooden privacy fence built at the levee toe.

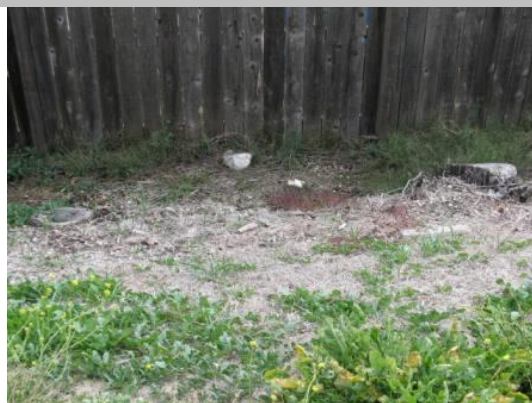
Photo 1 of 1 : FA_2018_NA0001_51_178_20180911_00058.jpg

LM Start	1.36	Rating **	N	Issue No.	178
LM End	1.36	Issue Type +	Ma	Location *	LS
Category	Earthen Levee			GPS Latitude/Longitude	
				Start	End
Item	Trim / Thin Trees			38.626063 °	38.626063 °
				-121.444988 °	-121.444988 °
DWR ID	DWR_NA0001_01_s_2012_178				
Comment Code					
T5 : Tree stumps.					
Inspector Comment					
Two stumps at landside toe.

11/17/2011 Two stumps at levee toe.

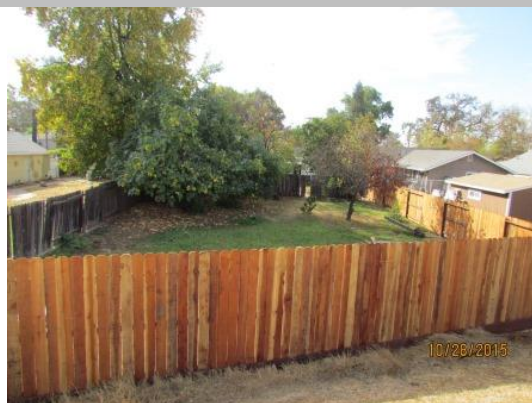
Photo 1 of 1 : FA_2018_NA0001_51_15_20180911_00014.jpg

LM Start	1.37	Rating **	U	Issue No.	15
LM End	1.37	Issue Type +	En	Location *	LS
Category	Earthen Levee			GPS Latitude/Longitude	
				Start	End
Item	Encroachments			38.626048 °	38.626048 °
				-121.444785 °	-121.444785 °
DWR ID	DWR_NA0001_01_s_2012_15				
Comment Code					
FE : Fence					
Inspector Comment					
Wooden privacy fence LS toe.

View of the fence at the landside levee toe.

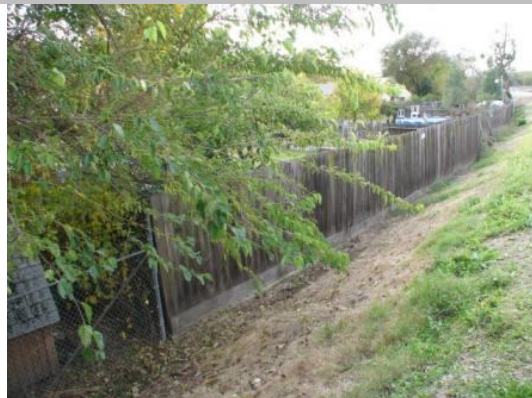
Photo 1 of 1 : FA_2018_NA0001_51_14_20180911_00013.jpg

LM Start	1.38	Rating **	U	Issue No.	14
LM End	1.38	Issue Type +	En	Location *	LS
Category	Earthen Levee			GPS Latitude/Longitude	
				Start	End
Item	Encroachments			38.626085 °	38.626085 °
				-121.444580 °	-121.444580 °
DWR ID	DWR_NA0001_01_s_2012_14				
Comment Code					
FE : Fence					
Inspector Comment					
Wooden privacy fence

11/17/2011 Wooden privacy fence built at the levee toe.

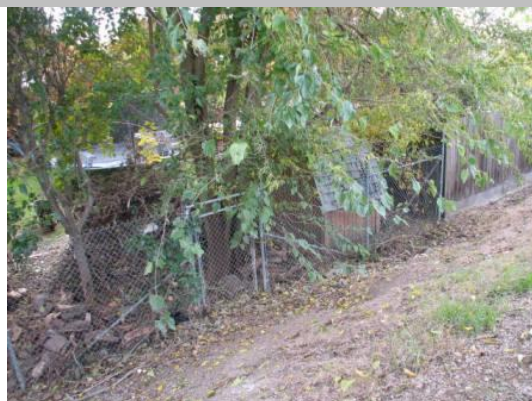
Photo 1 of 1 : FA_2018_NA0001_51_38_20180911_00028.jpg

LM Start	1.40	Rating **	M	Issue No.	38
LM End	1.40	Issue Type +	En	Location *	LS
Category	Earthen Levee			GPS Latitude/Longitude	
				Start	End
Item	Encroachments			38.626210 °	38.626210 °
				-121.444320 °	-121.444320 °
DWR ID	DWR_NA0001_01_s_2012_38				
Comment Code					
BU : Building					
Inspector Comment					
Small wooden storage shed and firewood are placed along chain link fence within 10-ft of levee toe.

11/17/2011 Shed and firewood can be seen through the chainlink fence.

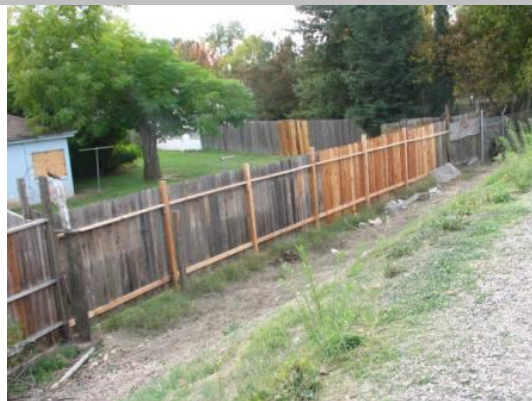
Photo 1 of 1 : FA_2018_NA0001_51_13_20180911_00012.jpg

LM Start	1.40	Rating **	U	Issue No.	13
LM End	1.40	Issue Type +	En	Location *	LS
Category	Earthen Levee			GPS Latitude/Longitude	
				Start	End
Item	Encroachments			38.626155 °	38.626155 °
				-121.444250 °	-121.444250 °
DWR ID	DWR_NA0001_01_s_2012_13				
Comment Code					
FE : Fence					
Inspector Comment					
Wooden fence with barbed wire is built within 10-ft of levee toe. 04/13/2011 Fence has blown over and now partially rests on the levee. Fall insp 2011 fence has been rebuilt in same location, within 10' of levee toe.

11/17/2011 New wooden privacy fence built within 15' of the levee toe.

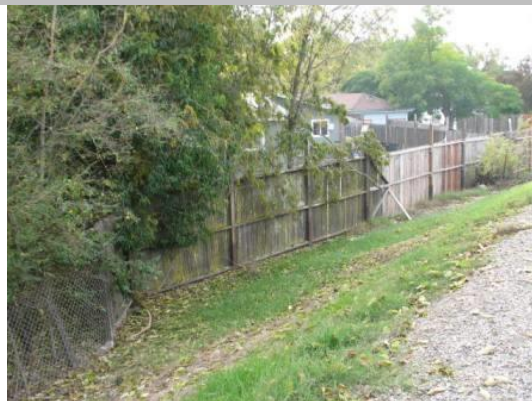
Photo 1 of 1 : FA_2018_NA0001_51_12_20180911_00011.jpg

LM Start	1.41	Rating **	U	Issue No.	12
LM End	1.41	Issue Type +	En	Location *	LS
Category	Earthen Levee			GPS Latitude/Longitude	
				Start	End
Item	Encroachments			38.626212 °	38.626212 °
				-121.444082 °	-121.444082 °
DWR ID	DWR_NA0001_01_s_2012_12				
Comment Code					
FE : Fence					
Inspector Comment					
Dog-eared wooden fence is built near the levee slope.

11/17/2011 Wooden privacy fence built within 15' of the levee toe.

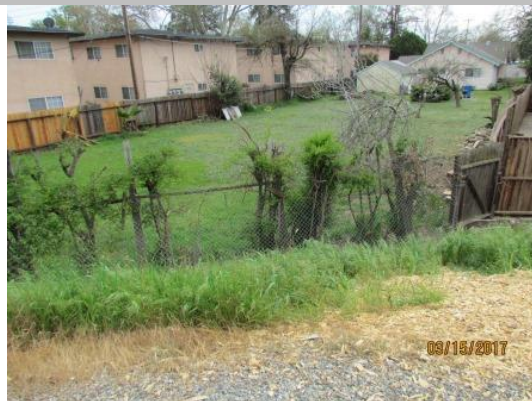
Photo 1 of 2 : FA_2018_NA0001_51_177_20180911_00056.jpg

LM Start	1.42	Rating **	M	Issue No.	177
LM End	1.42	Issue Type +	En	Location *	LS
Category	Earthen Levee			GPS Latitude/Longitude	
				Start	End
Item	Vegetation			38.626388 °	38.626388 °
				-121.443910 °	-121.443910 °
DWR ID	DWR_NA0001_01_s_2012_177				
Comment Code					
V6 : Landscaping					
Inspector Comment

Another view of the vegetation at levee toe. Spring 2017.

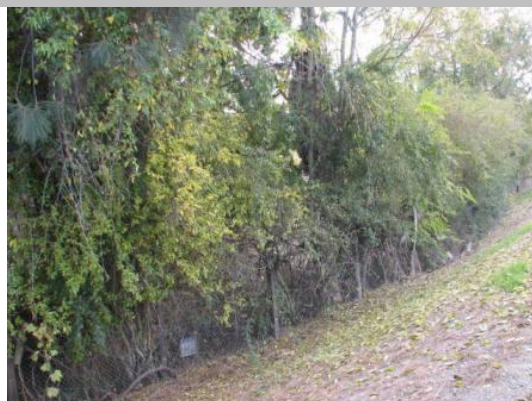
Photo 2 of 2 : FA_2018_NA0001_51_177_20180911_00057.jpg

LM Start	1.42	Rating **	M	Issue No.	177 (cont)	
LM End	1.42	Issue Type +	En	Location *	LS	
Category	Earthen Levee			GPS Latitude/Longitude		
				Start	End	
Item	Vegetation			38.626388 °	38.626388 °	
				-121.443910 °	-121.443910 °	
DWR ID	DWR_NA0001_01_s_2012_177					
Comment Code						
V6 : Landscaping						
Inspector Comment

11/17/2011 Thick vegetation at the levee toe.

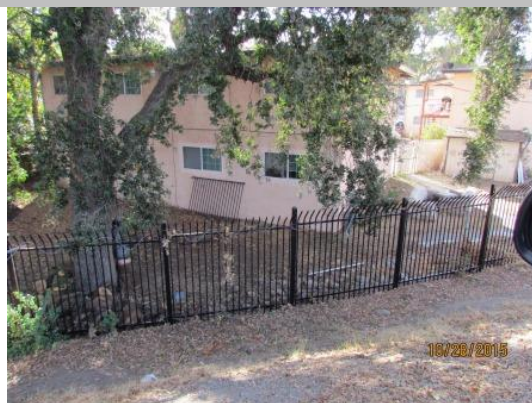
Photo 1 of 1 : FA_2018_NA0001_51_70_20180911_00046.jpg

LM Start	1.44	Rating **	U	Issue No.	70
LM End	1.44	Issue Type +	En	Location *	LS
Category	Earthen Levee			GPS Latitude/Longitude	
				Start	End
Item	Encroachments			38.626589 °	38.626589 °
				-121.443640 °	-121.443640 °
DWR ID	DWR_NA0001_01_f_2015_70				
Comment Code					
FE : Fence					
Inspector Comment					
Rought iron fence at LS toe blocks access.

View of the fence at the landside levee toe.

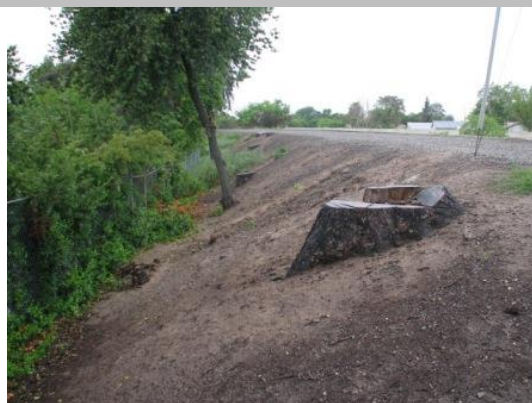
Photo 1 of 1 : FA_2018_NA0001_51_56_20180911_00036.jpg

LM Start	1.51	Rating **	N	Issue No.	56
LM End	1.52	Issue Type +	Ma	Location *	LS
Category	Earthen Levee			GPS Latitude/Longitude	
				Start	End
Item	Trim / Thin Trees			38.627180 °	38.627224 °
				-121.442718 °	-121.442515 °
DWR ID	DWR_NA0001_01_s_2012_56				
Comment Code					
T5 : Tree stumps.					
Inspector Comment					
4 stumps 14 to 30 Inches in diameter.

Several large stumps on levee slope.

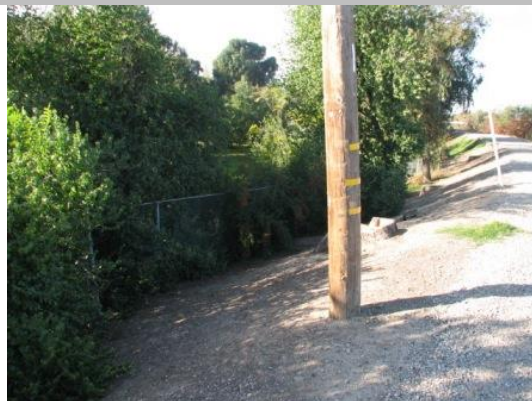
Photo 1 of 1 : FA_2018_NA0001_51_35_20180911_00027.jpg

LM Start	1.53	Rating **	M	Issue No.	35
LM End	1.53	Issue Type +	En	Location *	LS
Category	Earthen Levee			GPS Latitude/Longitude	
				Start	End
Item	Vegetation			38.627255 °	38.627255 °
				-121.442402 °	-121.442402 °
DWR ID	DWR_NA0001_01_s_2012_35				
Comment Code					
V6 : Landscaping					
Inspector Comment					
Bushes and trees along chain link fence block access and visibility.

Fall 2009 photo:Vegetation obstructing visibility near levee slope.

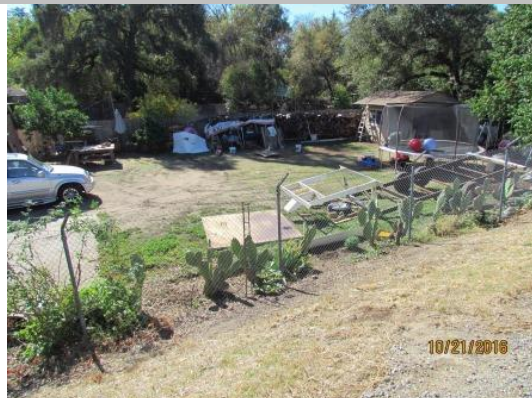
Photo 1 of 1 : FA_2018_NA0001_51_68_20180911_00045.jpg

LM Start	1.54	Rating **	M	Issue No.	68
LM End	1.54	Issue Type +	En	Location *	LS
Category	Earthen Levee			GPS Latitude/Longitude	
				Start	End
Item	Vegetation			38.627283 °	38.627283 °
				-121.442180 °	-121.442180 °
DWR ID	DWR_NA0001_01_f_2015_68				
Comment Code					
V6 : Landscaping					
Inspector Comment					
Cactus planted along LS toe.

View of the landscaping at the landside levee toe.

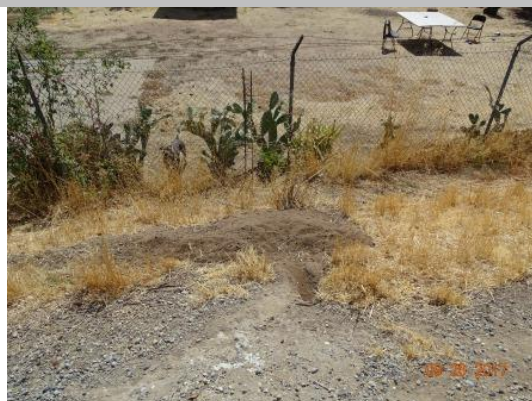
Photo 1 of 1 : FA_2018_NA0001_51_11_20180911_00010.jpg

LM Start	1.54	Rating **	M	Issue No.	11
LM End	1.54	Issue Type +	Ma	Location *	LS
Category	Earthen Levee			GPS Latitude/Longitude	
				Start	End
Item	Animal Control			38.627298 °	38.627298 °
				-121.442131 °	-121.442131 °
DWR ID	DWR_NA0001_01_f_2017_11				
Comment Code					
A3 : No rodents visible, but rodent burrows visible; need to backfill and compact or grout burrows.					
Inspector Comment					
Area shows signs of rodent activity.

View of the rodent activity on the levee slope.

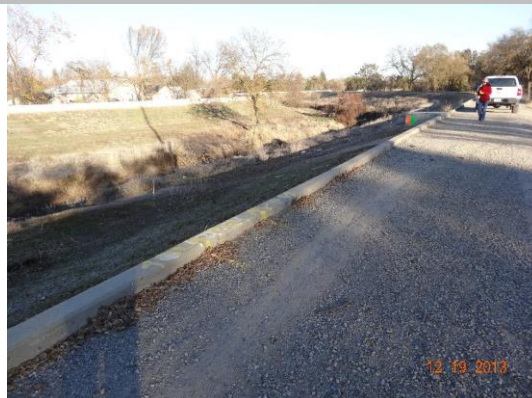
Photo 3 of 3 : UCIP_FA_2018_52671_57071.jpg

Comment Code						
Inspector Comment						
FS_ID:52671 DS_ID:24573 EP_NO: N/A Repair Type: Non-Urgent Crossing Status: Indicator Found UCIP Comments: 08/11/2017 PG&E records for DFM 0614-13 indicate that there were no observations found on the 07/2017 patrol, no leaks found on the 04/2017 leak survey, and the pipeline is operating correctly according to the 11/2016 CP inspection. (DWR UCIP - A. McDonald)11/12/15 Markers have been installed on both levees--confirmed during DWR Fall Inspection. Need to coordinate with PG&E to determine permit for this crossing. (DWR UCIP - O. Magana) 12/19/13 No markers visible indicating crossing through levee. PG&E line. Need to coordinate with owner. Permit? (DWR UCIP - O. Magana) FIELD_STRUCT_DESC: 2 of 2: 6-inch pipe through the levee, at an unknown depth and goes under the channel. In case of an emergency related to this pipeline, PG&E has identified the following contacts: PG&E's local pipeline engineer, Mike Aronoff at 916-307-9472 (cell), and Gas Control (north) at 800-442-4743. For non-emergency issues, please contact the local PG&E Gas Pipeline Operations and Maintenance (GPOM) supervisors for the Sacramento region, David Wade at 209-639-1039 (cell), or Ron Hicks at 916-396-9038 (cell). [Additional Reference(s): DWR Levee Log, 2002] FS Date: 11/12/2015 1:52:00 PM

View of waterward side.

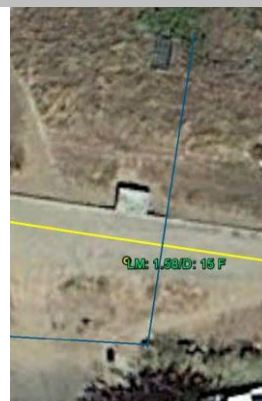
Photo 1 of 3 : UCIP_FA_2018_31182_57075.jpg

Comment Code					
Inspector Comment					
FS_ID:31182 DS_ID:24255 EP_NO: N/A Repair Type: Non-Urgent Crossing Status: Found UCIP Comments: 08/16/2017 DWR Deferred Maintenance Project (DMP), Vince Rodriguez, forwarded email received from Tim Kerr, General Manager of American River Flood Control District (ARFCD) with file "DWR Eligible Pipes Found in ARFCD" from ARFCD that shows the ownership and location of the pipes Tim Kerr investigated. Owner of this crossing is identified as the City of Sacramento, ARFCD Staff Notes indicate Arcade Ck at Belden St. (DWR UCIP - O. Magana) 06/06/2017 Received documentation from the City of Sacramento indicating that this crossing was internally inspected on 11/26/2013, PACP Sewer Report was provided. No additional information was received from the City of Sacramento. Need to request evaluation of pipe (integrity of pipe section through the levee) and clarify pipe size. (DWR UCIP – O. Magana) 01/29/14 approximate alignment of crossings was provided by the City of Sacramento for known crossings through levee. Unable to confirm last inspection. Also City records indicate 24-inch CMP not 15-inch--need to clarify with owner. Crossing is operational. FIELD_STRUCT_DESC: 15-inch drainage pipe of unknown material (City records indicate a 24-inch reinforced concrete pipe (RCP) at this location) through the levee, 8.5 feet below the crown. Flap gate on the waterside (WS) end. (no permit was found authorizing this pipe - the City of Sacramento is the owner of this pipe) [Additional Reference(s): DWR Levee Log, 2002] FS Date: 12/19/2013

Alignment in blue is an estimate of pipe alignment provided by the City of Sacramento. The symbol at LM 1.58 is field confirmed location.

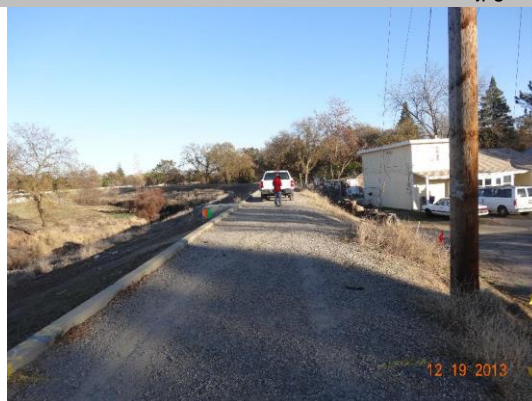
Photo 2 of 3 : UCIP_FA_2018_31182_57076.jpg

Comment Code					
Inspector Comment					
FS_ID:31182 DS_ID:24255 EP_NO: N/A Repair Type: Non-Urgent Crossing Status: Found UCIP Comments: 08/16/2017 DWR Deferred Maintenance Project (DMP), Vince Rodriguez, forwarded email received from Tim Kerr, General Manager of American River Flood Control District (ARFCD) with file "DWR Eligible Pipes Found in ARFCD" from ARFCD that shows the ownership and location of the pipes Tim Kerr investigated. Owner of this crossing is identified as the City of Sacramento, ARFCD Staff Notes indicate Arcade Ck at Belden St. (DWR UCIP - O. Magana) 06/06/2017 Received documentation from the City of Sacramento indicating that this crossing was internally inspected on 11/26/2013, PACP Sewer Report was provided. No additional information was received from the City of Sacramento. Need to request evaluation of pipe (integrity of pipe section through the levee) and clarify pipe size. (DWR UCIP – O. Magana) 01/29/14 approximate alignment of crossings was provided by the City of Sacramento for known crossings through levee. Unable to confirm last inspection. Also City records indicate 24-inch CMP not 15-inch--need to clarify with owner. Crossing is operational. FIELD_STRUCT_DESC: 15-inch drainage pipe of unknown material (City records indicate a 24-inch reinforced concrete pipe (RCP) at this location) through the levee, 8.5 feet below the crown. Flap gate on the waterside (WS) end. (no permit was found authorizing this pipe - the City of Sacramento is the owner of this pipe) [Additional Reference(s): DWR Levee Log, 2002] FS Date: 12/19/2013

Overview of levee at crossing.

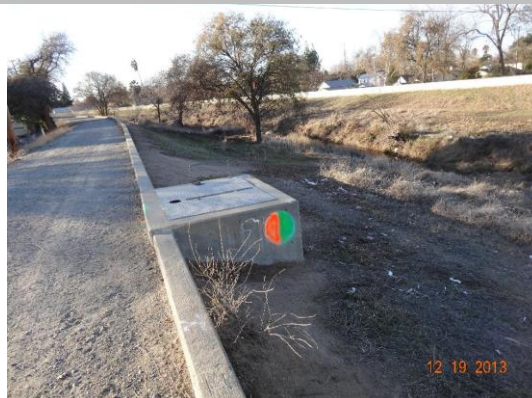
Photo 3 of 3 : UCIP_FA_2018_31182_57077.jpg

Comment Code						
Inspector Comment						
FS_ID:31182 DS_ID:24255 EP_NO: N/A Repair Type: Non-Urgent Crossing Status: Found UCIP Comments: 08/16/2017 DWR Deferred Maintenance Project (DMP), Vince Rodriguez, forwarded email received from Tim Kerr, General Manager of American River Flood Control District (ARFCD) with file "DWR Eligible Pipes Found in ARFCD" from ARFCD that shows the ownership and location of the pipes Tim Kerr investigated. Owner of this crossing is identified as the City of Sacramento, ARFCD Staff Notes indicate Arcade Ck at Belden St. (DWR UCIP - O. Magana) 06/06/2017 Received documentation from the City of Sacramento indicating that this crossing was internally inspected on 11/26/2013, PACP Sewer Report was provided. No additional information was received from the City of Sacramento. Need to request evaluation of pipe (integrity of pipe section through the levee) and clarify pipe size. (DWR UCIP – O. Magana) 01/29/14 approximate alignment of crossings was provided by the City of Sacramento for known crossings through levee. Unable to confirm last inspection. Also City records indicate 24-inch CMP not 15-inch--need to clarify with owner. Crossing is operational. FIELD_STRUCT_DESC: 15-inch drainage pipe of unknown material (City records indicate a 24-inch reinforced concrete pipe (RCP) at this location) through the levee, 8.5 feet below the crown. Flap gate on the waterside (WS) end. (no permit was found authorizing this pipe - the City of Sacramento is the owner of this pipe) [Additional Reference(s): DWR Levee Log, 2002] FS Date: 12/19/2013

View of concrete vault located on waterward apex.

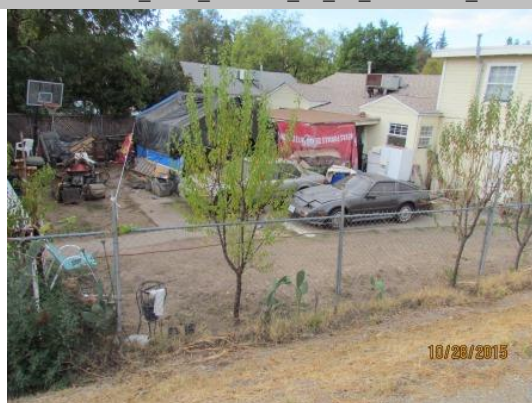
Photo 1 of 1 : FA_2018_NA0001_51_67_20180911_00044.jpg

LM Start	1.60	Rating **	M	Issue No.	67
LM End	1.60	Issue Type +	En	Location *	LS
Category	Earthen Levee			GPS Latitude/Longitude	
				Start	End
Item	Encroachments			38.627207 °	38.627207 °
				-121.441104 °	-121.441104 °
DWR ID	DWR_NA0001_01_f_2015_67				
Comment Code					
FE : Fence					
Inspector Comment					
Fence at landside levee toe. 6 fruit trees and various cactus plants at LS toe.

View of the fence and landscaping at the landside levee toe.

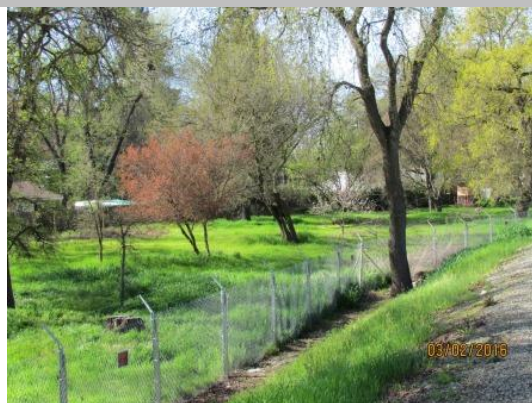
Photo 1 of 1 : FA_2018_NA0001_51_66_20180911_00043.jpg

LM Start	1.61	Rating **	M	Issue No.	66
LM End	1.68	Issue Type +	En	Location *	LS
Category	Earthen Levee			GPS Latitude/Longitude	
				Start	End
Item	Encroachments			38.627195 °	38.627500 °
				-121.440974 °	-121.439766 °
DWR ID	DWR_NA0001_01_f_2015_66				
Comment Code					
FE : Fence					
Inspector Comment					
Fence at landside levee toe.

View of the fence at the landside levee toe.

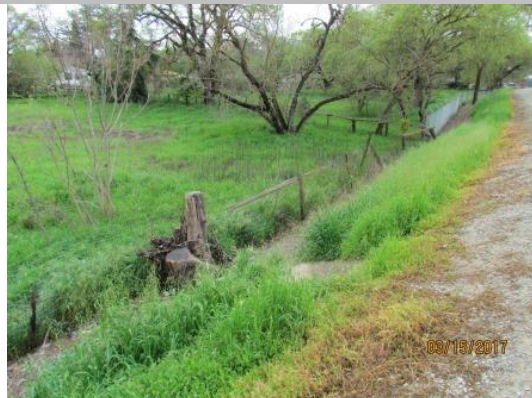
Photo 1 of 1 : FA_2018_NA0001_51_74_20180911_00048.jpg

LM Start	1.69	Rating **	N	Issue No.	74
LM End	1.69	Issue Type +	Ma	Location *	LS
Category	Earthen Levee			GPS Latitude/Longitude	
				Start	End
Item	Trim / Thin Trees			38.627607 °	38.627607 °
				-121.439545 °	-121.439545 °
DWR ID	DWR_NA0001_01_s_2017_74				
Comment Code					
T5 : Tree stumps.					
Inspector Comment					
24 inch large tree stump at levee toe.

View of the tree stump at the levee toe.

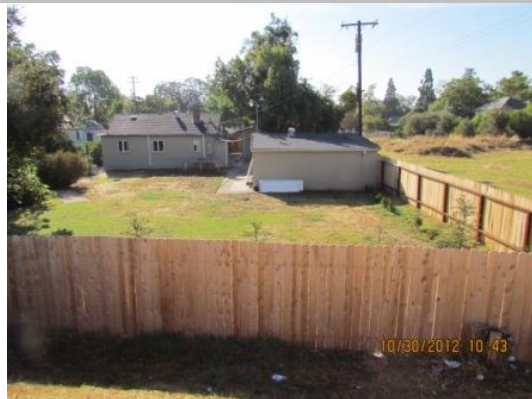
Photo 1 of 1 : FA_2018_NA0001_51_10_20180911_00009.jpg

LM Start	1.79	Rating **	U	Issue No.	10
LM End	1.79	Issue Type +	En	Location *	LS
Category	Earthen Levee			GPS Latitude/Longitude	
				Start	End
Item	Encroachments			38.627948 °	38.627948 °
				-121.437682 °	-121.437682 °
DWR ID	DWR_NA0001_01_f_2012_10				
Comment Code					
FE : Fence					
Inspector Comment					
Wooden fence constructed at LS levee toe.

View of new fence constructed at levee toe and 7 redwood trees planted behind fence within easement.

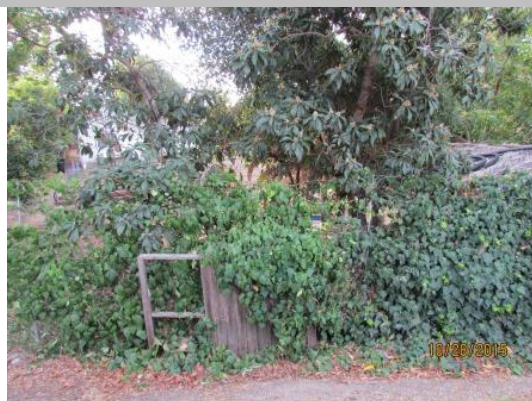
Photo 1 of 1 : FA_2018_NA0001_51_170_20180911_00054.jpg

LM Start	1.81	Rating **	U	Issue No.	170
LM End	1.81	Issue Type +	En	Location *	LS
Category	Earthen Levee			GPS Latitude/Longitude	
				Start	End
Item	Vegetation			38.627934 °	38.627934 °
				-121.437423 °	-121.437423 °
DWR ID	DWR_NA0001_01_s_2012_170				
Comment Code					
V6 : Landscaping					
Inspector Comment					
Growth on old wooden fence, which has since been replaced by a chainlink fence is obstructive.

View of the landscaping at the landside levee toe.

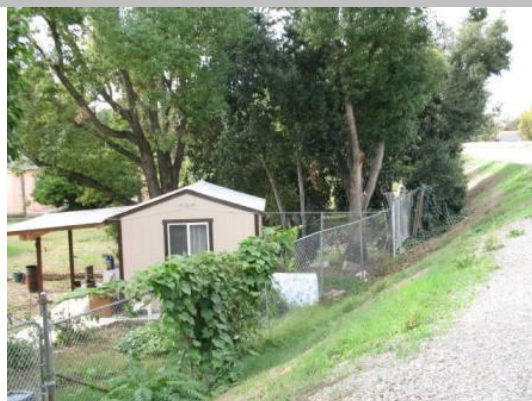
Photo 1 of 1 : FA_2018_NA0001_51_169_20180911_00053.jpg

LM Start	1.82	Rating **	U	Issue No.	169
LM End	1.82	Issue Type +	En	Location *	LS
Category	Earthen Levee			GPS Latitude/Longitude	
				Start	End
Item	Encroachments			38.627922 °	38.627922 °
				-121.437296 °	-121.437296 °
DWR ID	DWR_NA0001_01_s_2012_169				
Comment Code					
BU : Building					
Inspector Comment					
Shed on concrete pad within 10' of the levee toe.

11/17/2011 Wooden shed on concrete pad built within 15' of levee toe.

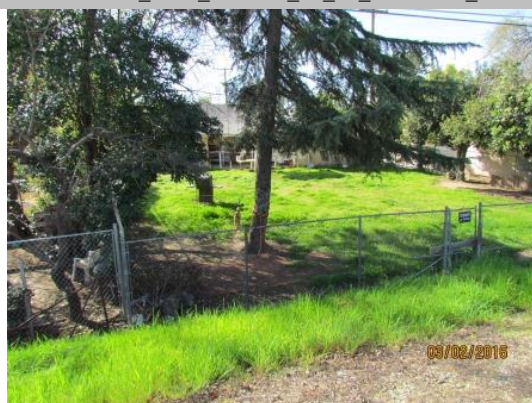
Photo 1 of 1 : FA_2018_NA0001_51_63_20180911_00041.jpg

LM Start	1.84	Rating **	M	Issue No.	63
LM End	1.84	Issue Type +	En	Location *	LS
Category	Earthen Levee			GPS Latitude/Longitude	
				Start	End
Item	Encroachments			38.627879 °	38.627879 °
				-121.436889 °	-121.436889 °
DWR ID	DWR_NA0001_01_f_2015_63				
Comment Code					
FE : Fence					
Inspector Comment					
Fence at landside levee toe.

View of the fence at the landside levee toe.

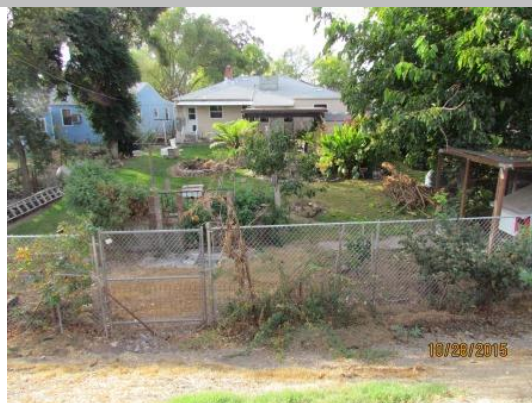
Photo 1 of 1 : FA_2018_NA0001_51_9_20180911_00008.jpg

LM Start	1.85	Rating **	M	Issue No.	9
LM End	1.85	Issue Type +	En	Location *	LS
Category	Earthen Levee			GPS Latitude/Longitude	
				Start	End
Item	Encroachments			38.627884 °	38.627884 °
				-121.436682 °	-121.436682 °
DWR ID	DWR_NA0001_01_s_2012_9				
Comment Code					
FE : Fence					
Inspector Comment

View of the fence at the landside levee toe.

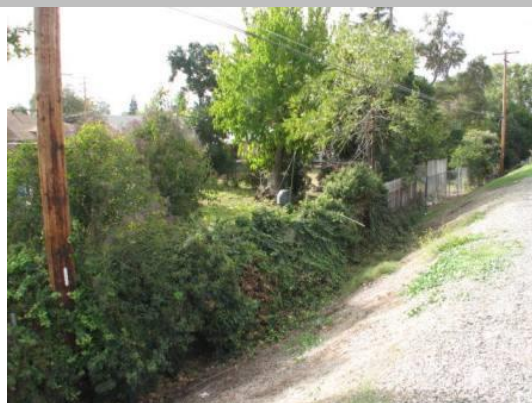
Photo 1 of 1 : FA_2018_NA0001_51_8_20180911_00007.jpg

LM Start	1.85	Rating **	M	Issue No.	8
LM End	1.85	Issue Type +	En	Location *	LS
Category	Earthen Levee			GPS Latitude/Longitude	
				Start	End
Item	Vegetation			38.627889 °	38.627889 °
				-121.436638 °	-121.436638 °
DWR ID	DWR_NA0001_01_s_2012_8				
Comment Code					
V6 : Landscaping					
Inspector Comment					
Ivy, trees and other landscaping growing on a privacy fence are obstructing visibility.

11/17/2011 Landscaping vegetation growth on the fence is obstructive.

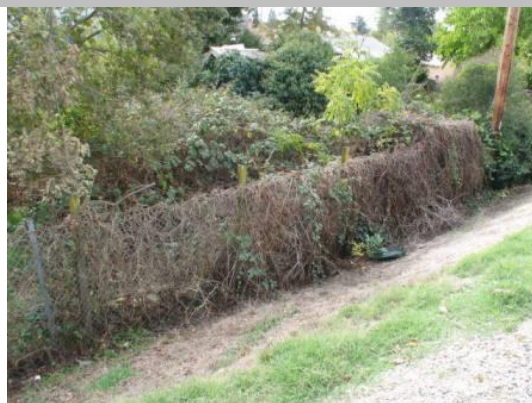
Photo 1 of 1 : FA_2018_NA0001_51_7_20180911_00006.jpg

LM Start	1.86	Rating **	U	Issue No.	7
LM End	1.86	Issue Type +	En	Location *	LS
Category	Earthen Levee			GPS Latitude/Longitude	
				Start	End
Item	Vegetation			38.627889 °	38.627889 °
				-121.436454 °	-121.436454 °
DWR ID	DWR_NA0001_01_s_2012_7				
Comment Code					
V6 : Landscaping					
Inspector Comment					
Metal sided shelter, blackberries and cherry trees are obstructive.

11/17/2011 Blackberries growing on fence are obstructive.

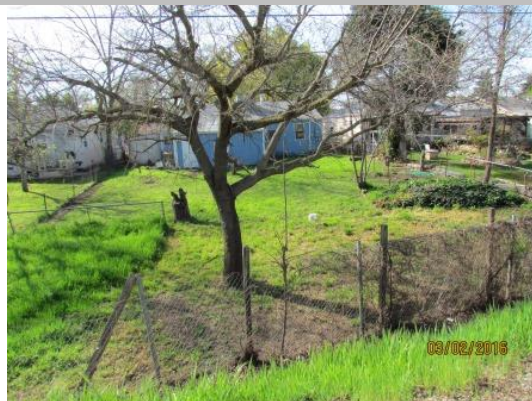
Photo 1 of 1 : FA_2018_NA0001_51_61_20180911_00040.jpg

LM Start	1.86	Rating **	M	Issue No.	61
LM End	1.86	Issue Type +	En	Location *	LS
Category	Earthen Levee			GPS Latitude/Longitude	
				Start	End
Item	Encroachments			38.627885 °	38.627885 °
				-121.436423 °	-121.436423 °
DWR ID	DWR_NA0001_01_f_2015_61				
Comment Code					
FE : Fence					
Inspector Comment					
Fence at landside levee toe.

View of the fence at the landside levee toe.

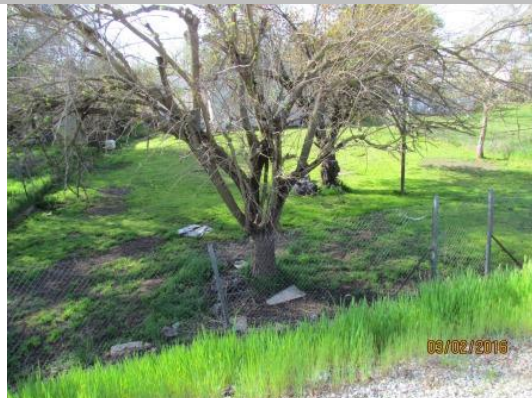
Photo 1 of 1 : FA_2018_NA0001_51_59_20180911_00039.jpg

LM Start	1.88	Rating **	M	Issue No.	59
LM End	1.88	Issue Type +	En	Location *	LS
Category	Earthen Levee			GPS Latitude/Longitude	
				Start	End
Item	Encroachments			38.627871 °	38.627871 °
				-121.436191 °	-121.436191 °
DWR ID	DWR_NA0001_01_f_2015_59				
Comment Code					
FE : Fence					
Inspector Comment					
Fence at landside levee toe.

View of the fence at the landside levee toe.

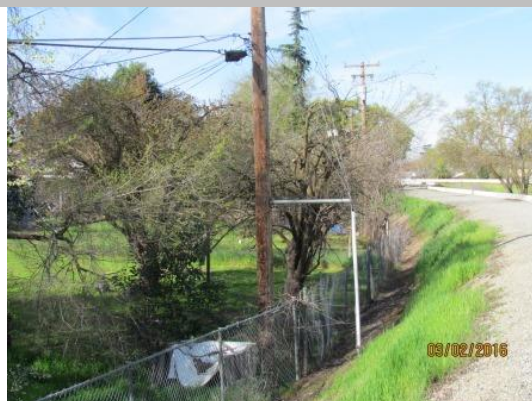
Photo 1 of 1 : FA_2018_NA0001_51_58_20180911_00038.jpg

LM Start	1.88	Rating **	M	Issue No.	58
LM End	1.88	Issue Type +	En	Location *	LS
Category	Earthen Levee			GPS Latitude/Longitude	
				Start	End
Item	Encroachments			38.627860 °	38.627860 °
				-121.436098 °	-121.436098 °
DWR ID	DWR_NA0001_01_f_2015_58				
Comment Code					
PO : Pole					
Inspector Comment					
Pole at the landside levee toe with guy wire penetrating the landside levee slope.

View of the pole at the landside levee toe.

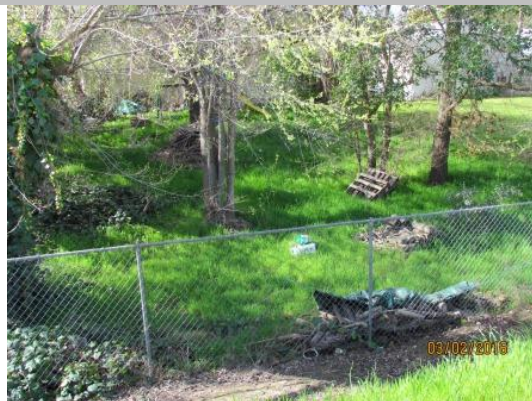
Photo 1 of 1 : FA_2018_NA0001_51_57_20180911_00037.jpg

LM Start	1.89	Rating **	M	Issue No.	57
LM End	1.89	Issue Type +	En	Location *	LS
Category	Earthen Levee			GPS Latitude/Longitude	
				Start	End
Item	Encroachments			38.627837 °	38.627837 °
				-121.435973 °	-121.435973 °
DWR ID	DWR_NA0001_01_f_2015_57				
Comment Code					
FE : Fence					
Inspector Comment					
Fence at landside levee toe.

View of the fence at the landside levee toe.

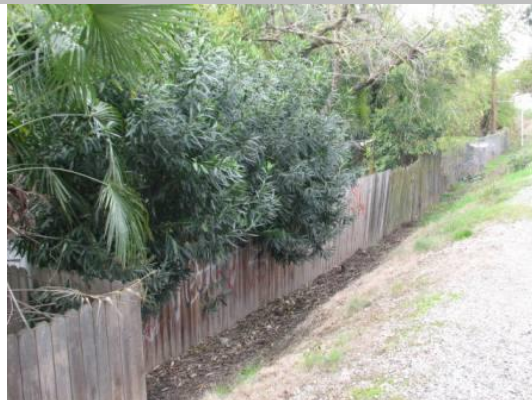
Photo 1 of 1 : FA_2018_NA0001_51_6_20180911_00005.jpg

LM Start	1.90	Rating **	U	Issue No.	6
LM End	1.90	Issue Type +	En	Location *	LS
Category	Earthen Levee			GPS Latitude/Longitude	
				Start	End
Item	Encroachments			38.627725 °	38.627725 °
				-121.435715 °	-121.435715 °
DWR ID	DWR_NA0001_01_s_2012_6				
Comment Code					
FE : Fence					
Inspector Comment					
Dog-eared wooden fence is built within 10-ft of the levee slope.

11/17/2011 Wooden privacy fence built at the levee toe.

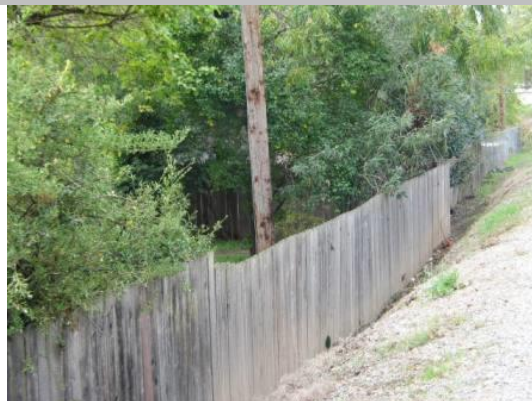
Photo 1 of 1 : FA_2018_NA0001_51_5_20180911_00004.jpg

LM Start	1.91	Rating **	U	Issue No.	5
LM End	1.91	Issue Type +	En	Location *	LS
Category	Earthen Levee			GPS Latitude/Longitude	
				Start	End
Item	Encroachments			38.627680 °	38.627680 °
				-121.435555 °	-121.435555 °
DWR ID	DWR_NA0001_01_s_2012_5				
Comment Code					
FE : Fence					
Inspector Comment					
Dog-eared wooden fence is built against the levee slope.

11/17/2011 Wooden privacy fence built at the levee toe.

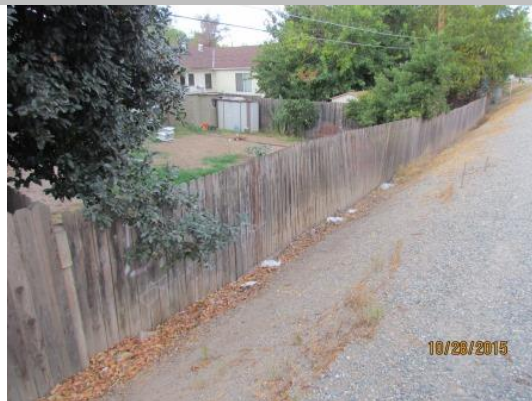
Photo 1 of 1 : FA_2018_NA0001_51_4_20180911_00003.jpg

LM Start	1.92	Rating **	U	Issue No.	4
LM End	1.92	Issue Type +	En	Location *	LS
Category	Earthen Levee			GPS Latitude/Longitude	
				Start	End
Item	Encroachments			38.627715 °	38.627715 °
				-121.435452 °	-121.435452 °
DWR ID	DWR_NA0001_01_s_2012_4				
Comment Code					
FE : Fence					
Inspector Comment					
Wooden fence and landscaping completely block visibility.

View of the wooden fence at the landside levee toe.

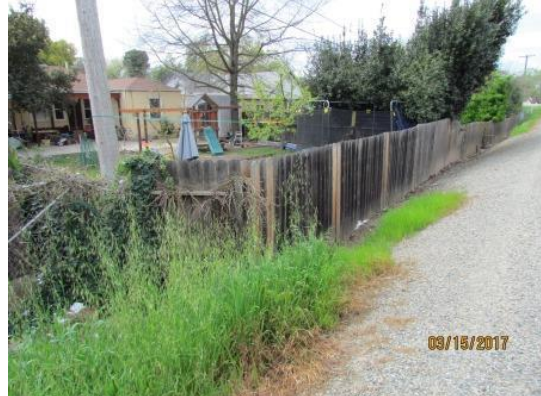
Photo 1 of 1 : FA_2018_NA0001_51_3_20180911_00002.jpg

LM Start	1.93	Rating **	U	Issue No.	3
LM End	1.93	Issue Type +	En	Location *	LS
Category	Earthen Levee			GPS Latitude/Longitude	
				Start	End
Item	Encroachments			38.627658 °	38.627658 °
				-121.435192 °	-121.435192 °
DWR ID	DWR_NA0001_01_s_2012_3				
Comment Code					
FE : Fence					
Inspector Comment					
Dog-eared wooden fence is built against the levee slope.

View of the fence at the landside levee toe. Spring 2017

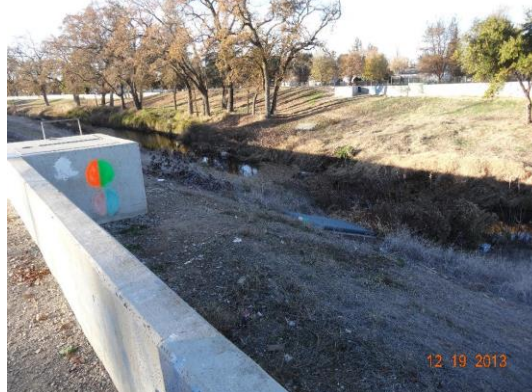
Photo 1 of 3 : UCIP_FA_2018_41549_57087.jpg

FS_ID:41549
DS_ID:24259
EP_NO: N/A
Repair Type: Non-Urgent
Crossing Status: Found
UCIP Comments: 08/16/2017 DWR Deferred Maintenance Project (DMP), Vince Rodriguez, forwarded email received from Tim Kerr, General Manager of American River Flood Control District (ARFCD) with file "DWR Eligible Pipes Found in ARFCD" from ARFCD that shows the ownership and location of the pipes Tim Kerr investigated. Owner of this crossing is identified as the City of Sacramento, ARFCD Staff Notes indicate Arcade Ck at Delmar Way. (DWR UCIP - O. Magana)
06/06/2017 Received documentation from the City of Sacramento indicating that this crossing was internally inspected on 01/15/2014, PACP Sewer Report was provided. No additional information was received from the City of Sacramento. Need to request evaluation of pipe (integrity of pipe section through the levee) and confirm pipe size. Conflicting information regarding pipe size was received from the City of Sacramento, PACP report indicates a 24-inch pipe, City alignment layer indicates a 10-inch pipe and UCIP's record indicates a 15-inch pipe. (DWR UCIP - O. Magana)

View of waterward side--concrete vault and u-shape concrete headwall with debris screen.

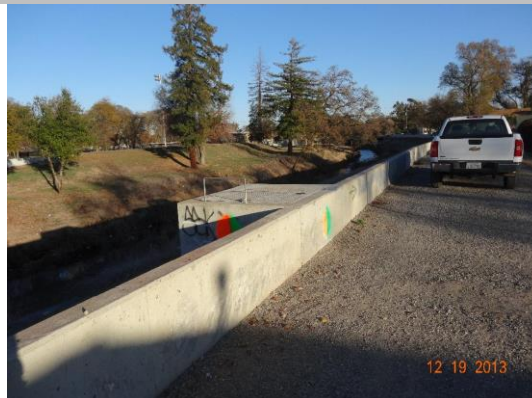
Photo 2 of 3 : UCIP_FA_2018_41549_57086.jpg

View of floodwall along waterward side.

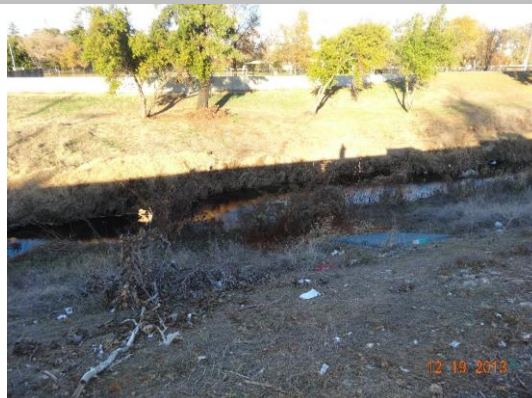
Photo 3 of 3 : UCIP_FA_2018_41549_57085.jpg

Comment Code						
Inspector Comment						
FS_ID:41549 DS_ID:24259 EP_NO: N/A Repair Type: Non-Urgent Crossing Status: Found UCIP Comments: 08/16/2017 DWR Deferred Maintenance Project (DMP), Vince Rodriguez, forwarded email received from Tim Kerr, General Manager of American River Flood Control District (ARFCD) with file "DWR Eligible Pipes Found in ARFCD" from ARFCD that shows the ownership and location of the pipes Tim Kerr investigated. Owner of this crossing is identified as the City of Sacramento, ARFCD Staff Notes indicate Arcade Ck at Delmar Way. (DWR UCIP - O. Magana) 06/06/2017 Received documentation from the City of Sacramento indicating that this crossing was internally inspected on 01/15/2014, PACP Sewer Report was provided. No additional information was received from the City of Sacramento. Need to request evaluation of pipe (integrity of pipe section through the levee) and confirm pipe size. Conflicting information regarding pipe size was received from the City of Sacramento, PACP report indicates a 24-inch pipe, City alignment layer indicates a 10-inch pipe and UCIP's record indicates a 15-inch pipe. (DWR UCIP – O. Magana) 01/29/14 approximate alignment of crossings was provided by the City of Sacramento for known crossings through levee. Unable to confirm last inspection. Also City records indicate 10-inch not 15-inch--need to clarify with owner. Crossing is operational. (DWR UCIP - O. Magana) FIELD_STRUCT_DESC: 15-inch drainage pipe of unknown material through the levee, 8.5 feet below the crown. Flap gate is located on the waterside (WS) end. (no permit has been identified authorizing this structure, structure is owned by the City of Sacramento) [Additional Reference(s): DWR Levee Log, 2002] FS Date: 12/19/2013

Debris screen visible on waterward slope.

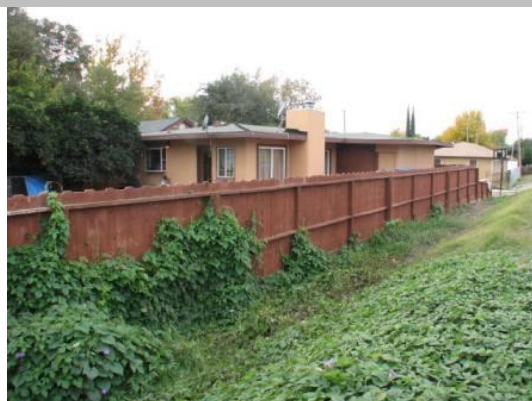
Photo 1 of 1 : FA_2018_NA0001_51_167_20180911_00052.jpg

LM Start	1.98	Rating **	U	Issue No.	167
LM End	1.98	Issue Type +	En	Location *	LS
Category	Earthen Levee			GPS Latitude/Longitude	
				Start	End
Item	Encroachments			38.627433 °	38.627433 °
				-121.434341 °	-121.434341 °
DWR ID	DWR_NA0001_01_s_2012_167				
Comment Code					
FE : Fence					
Inspector Comment					
Wooden privacy fence within 10' of the levee toe.

11/17/2011 Wooden privacy fence built at the levee toe.
